Manhole Inspection Summary

Manhole # S43C__023MH

Insp Date: **4/23/08 10:09 AM**

Location Address: **Fairmount Ave**

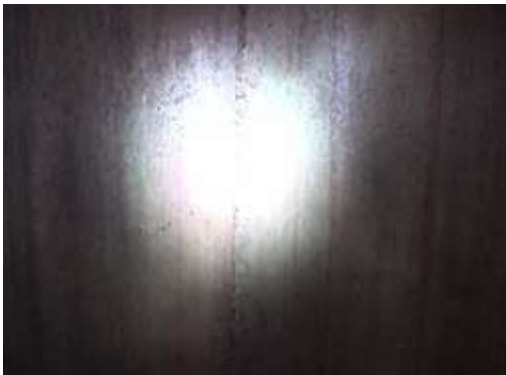
Defect 3

Condition: ☐ Sound ☒ **Cracked** ☐ Root Intrusion ☐ Loose Brick ☐ Deteriorated

crack in barrel

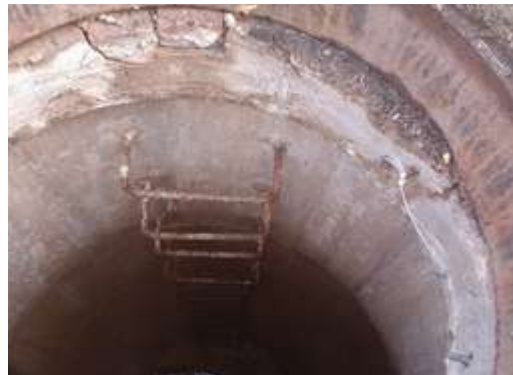
Defect 1

Condition: ☐ Sound ☐ Cracked ☐ Root Intrusion ☒ **Loose Brick** ☐ Deteriorated

loose bricks

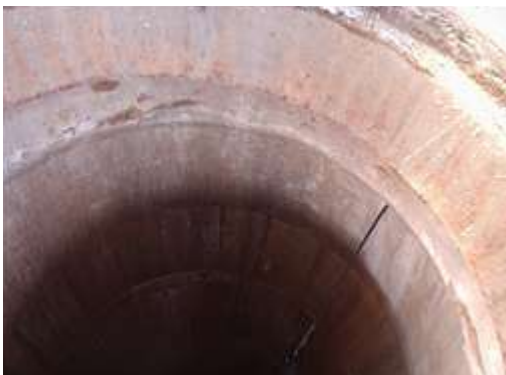
Defect 2

Infiltration: ☐ None ☒ **Joint** ☐ Cracks ☒ **Mortar** ☐ Roots ☐ Wall

Infiltration: ☐ None ☐ Joint ☐ Cracks ☐ Mortar ☐ Roots ☒ **Wall**

infiltration

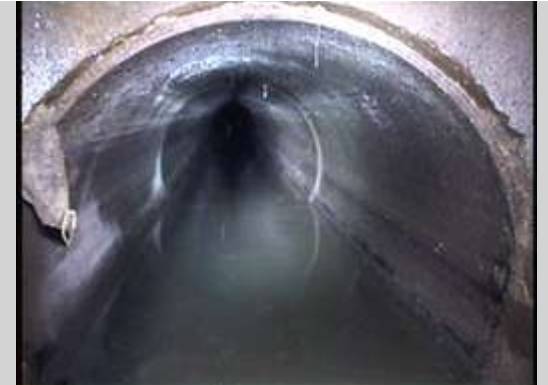
12 O'Clock Outflow

24 in. Circular Gravity Sewer
Pipe Out @ 12 O'Clock

Pipe Height: **24** (in.) Rod and Bar (Angled)
Pipe Material: **Clay** ☐ Pipe Lined
Invert Depth: **17.35** (ft.) Flow Characteristics: **Fast**
Deposits: ☒ None ☐ Mud ☐ Sludge ☐ Debris ☐ Grease
Silt Depth: (in.) Deposits Extent:
Infiltration: **None** Pipe Seal Cond: **Sound**

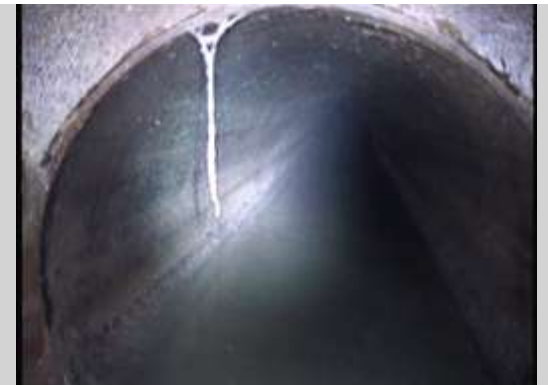
8 O'Clock Inflow

24 in. Circular Gravity Sewer
Pipe In @ 8 O'Clock

Pipe Height: **24** (in.) Rod and Bar (Angled)
Pipe Material: **Clay** ☐ Pipe Lined
Invert Depth: **17.35** (ft.) Flow Characteristics: **Fast**
Deposits: ☒ None ☐ Mud ☐ Sludge ☐ Debris ☐ Grease
Silt Depth: (in.) Deposits Extent:
Infiltration: **None** Pipe Seal Cond: **Sound**
